REMOVAL/INSTALLATION OF SEASTAR POWER ASSIST COUPLING

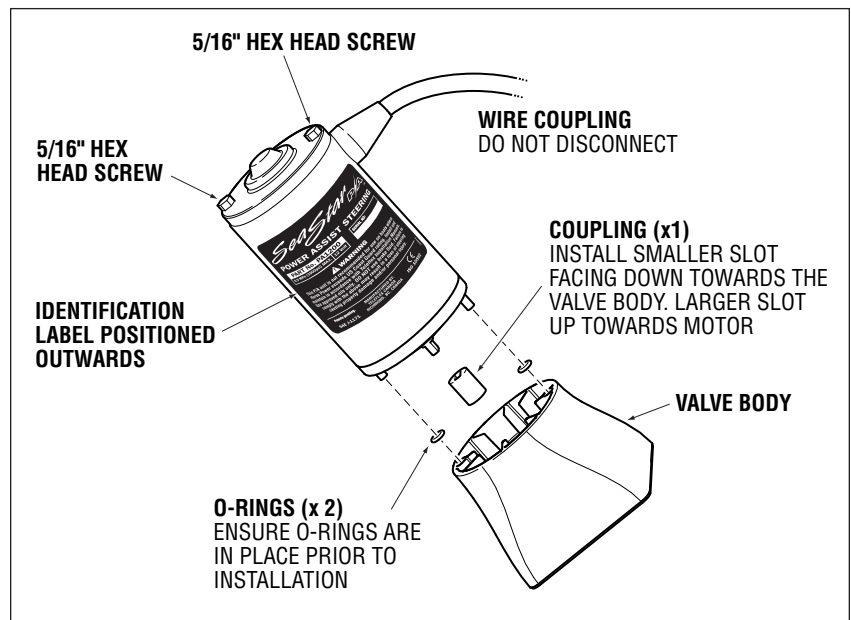
Figure A.

- 1 DO NOT disconnect the motor electrical connections, steering lines, or remove the rear cover enclosure from the power assist unit during the removal and/or installation of the new coupling.
- 2 Locate and loosen the two 5/16" hex head screws from the top of the motor being sure not to misplace the two o-rings that are on the bottom of the motor. (Refer to figure A.)
- 3 Remove and discard coupling located in the valve body (see figure A).

- 1 Install new coupling into valve body with the smaller of the two slots facing down.
- 2 Confirm that the 2 x o-rings are installed on the motor prior to installation.
- 3 Position motor so that the power assist identification label is facing outwards (see figure A).
- 4 Line-up the motor shaft to match the same position of the new coupling located in the valve body; ensure motor is correctly seated in place.
- 5 Tighten the 2 x 5/16" hex head bolts and torque to 14 in.lb. MAX.
- 6 Confirm proper operation of the Power Assist by taking your steering wheel hard over to hard over several times with the Power Assist Pump ON.
- 7 If Power Assist does not provide power assist, please contact Teleflex Technical support at the contacts noted below.
